OSI Scientific Superboard II, Keyboard switch fixing.

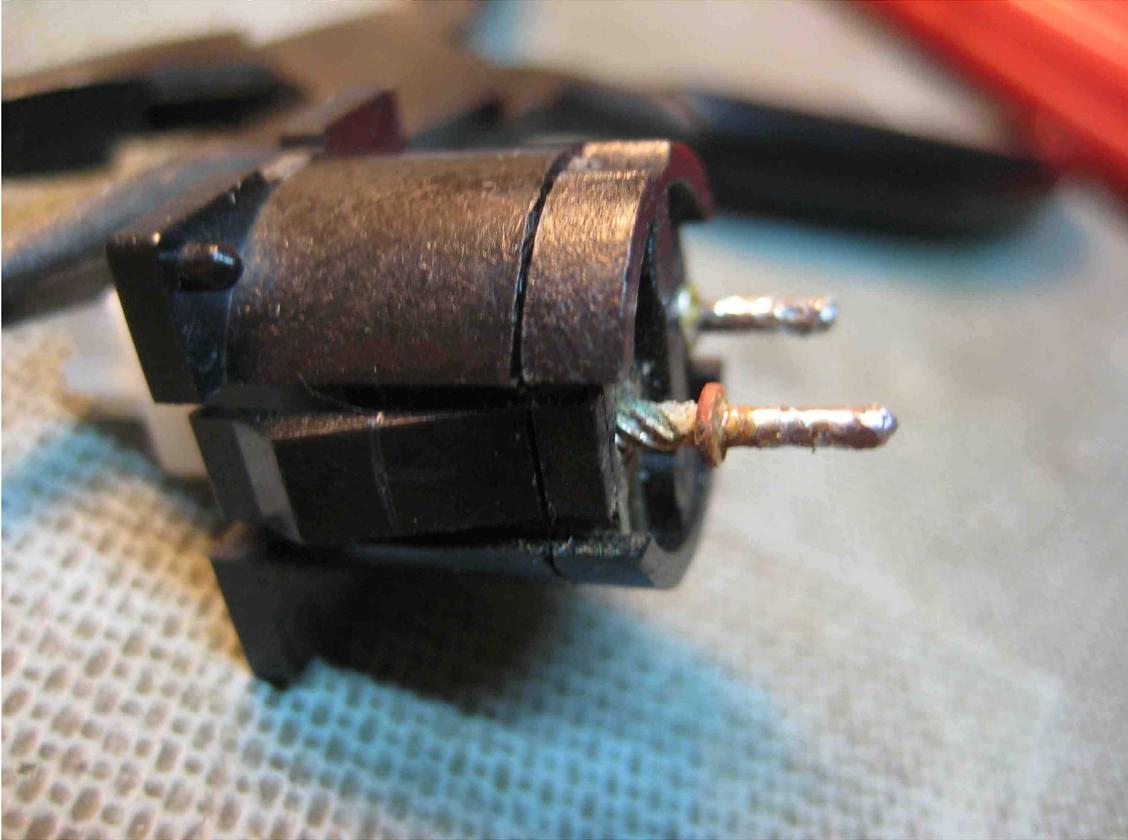
The back cap of the switch is held in place by the actual terminals. If you “unscrew” the posts slowly while gently pulling, they will come out.

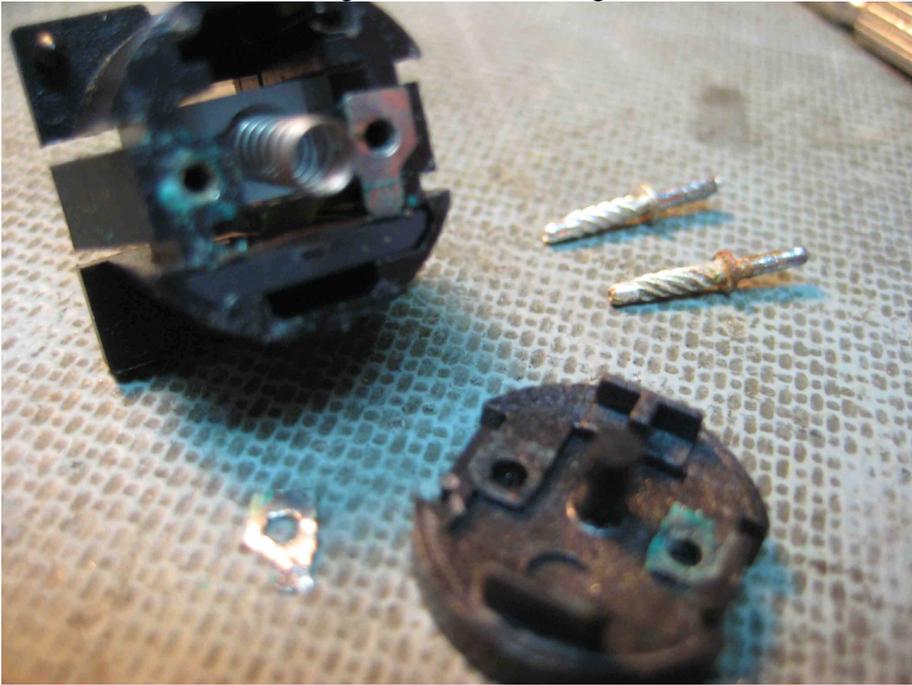
Next, I examined the damage and inner workings.

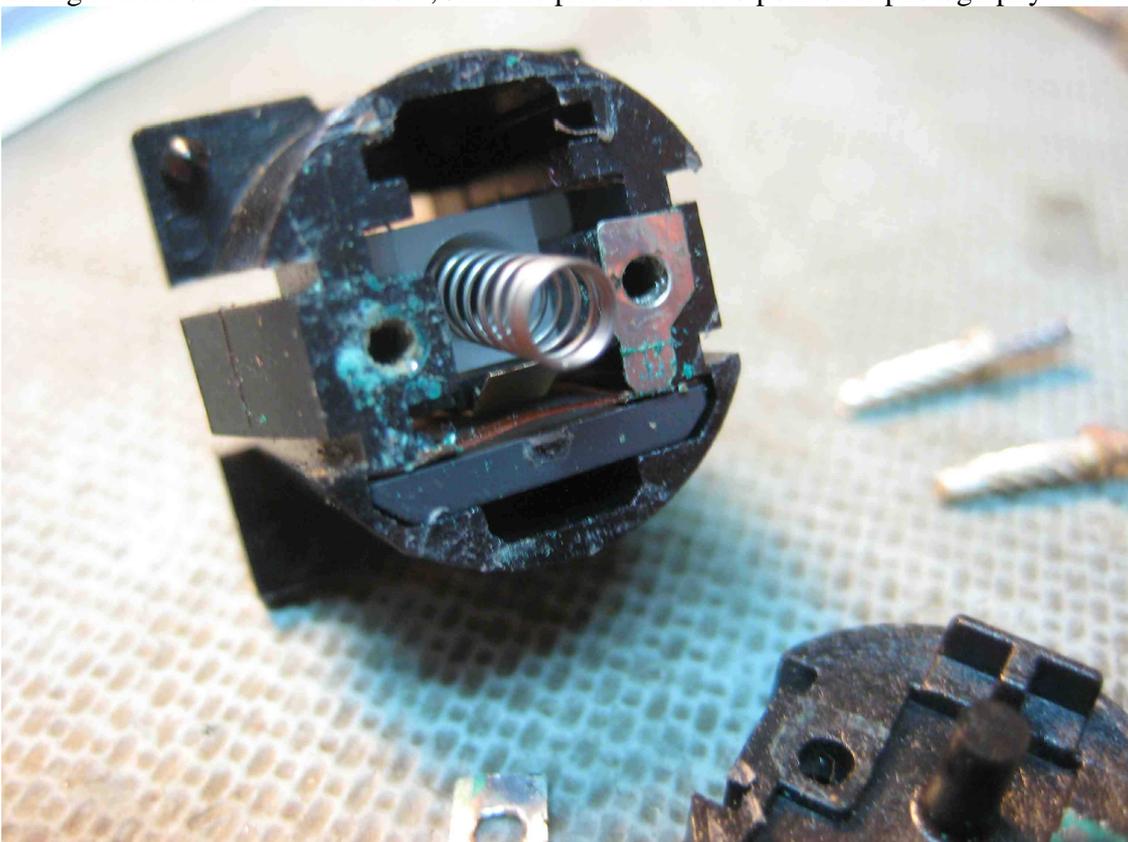
This particular switch failed due to corrosion from condensation. The whole board shows signs of corrosion. Some keys started functioning after “working” the switch but this switch would not function no matter how many times I banged on the key. Time to open it up... but how?

Zoom in for closer examination. See the switch lead broken on the left side? It's remains are right there on the bench below, 1/2 in the photo shot. No points for photography here!

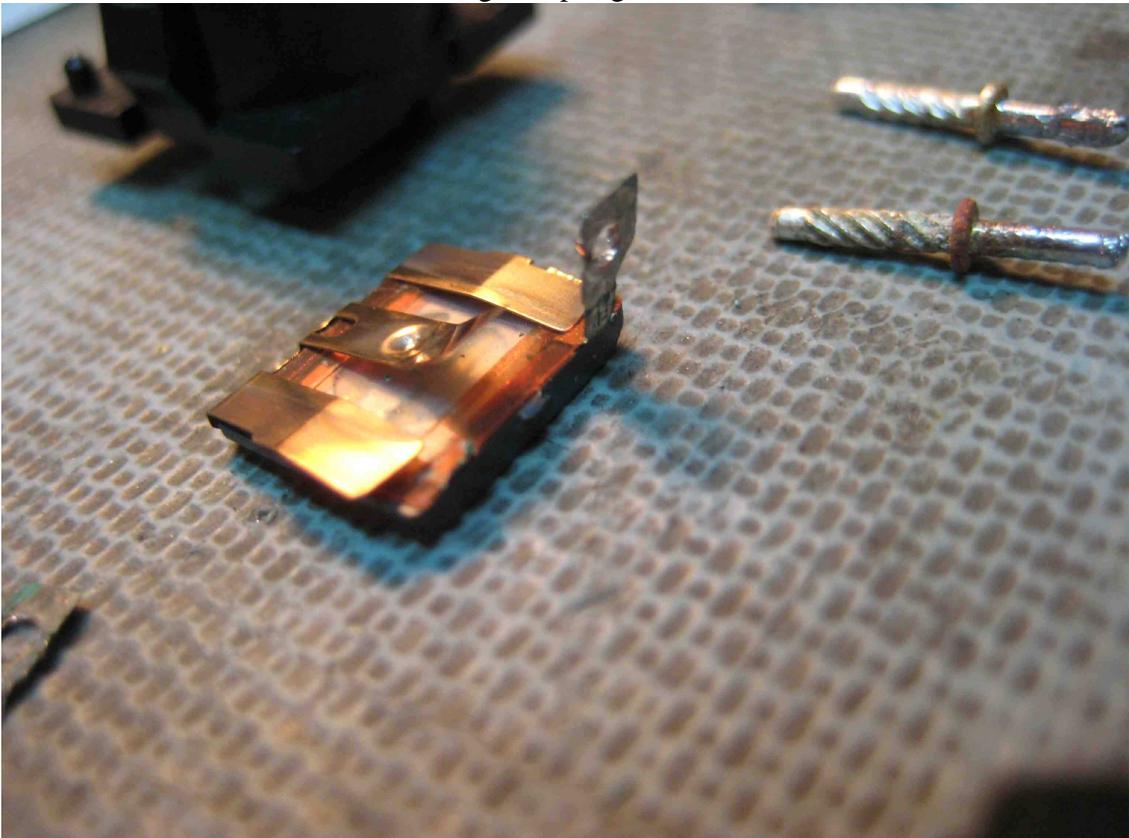
Here, the switch is out. You are seeing the spring metal actuator, not the contacts.

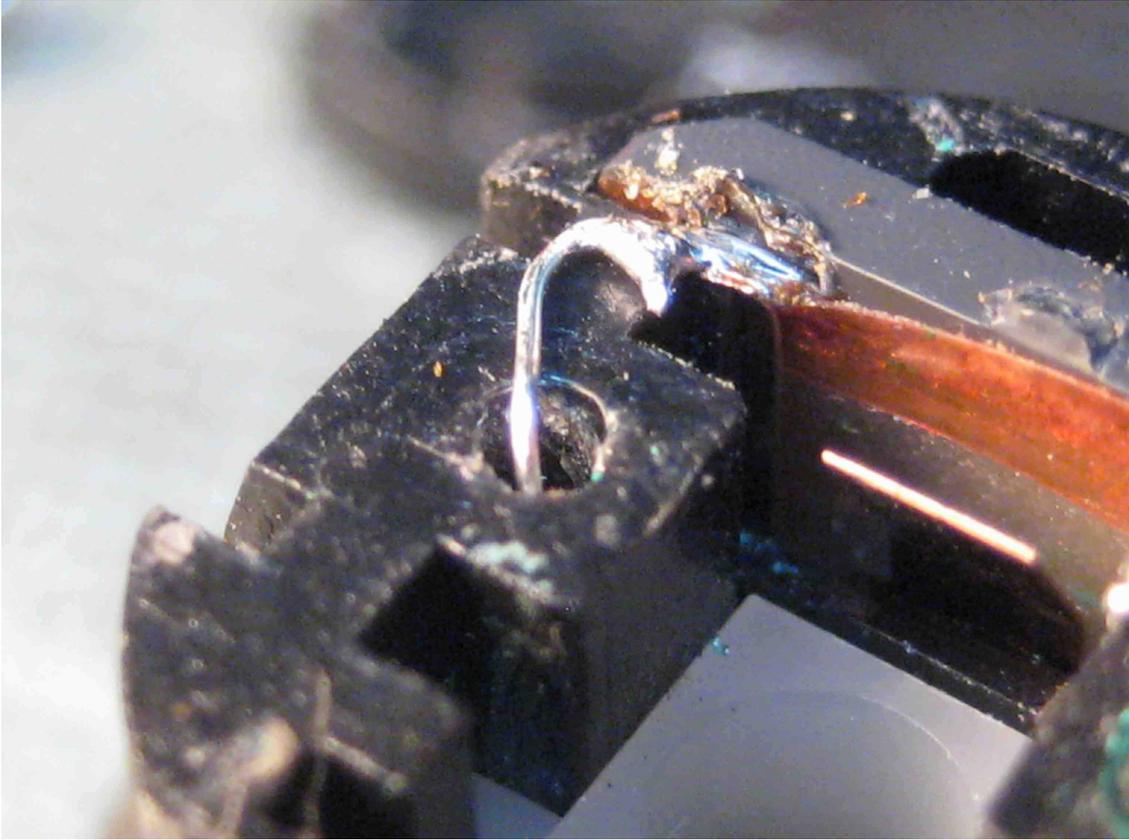
Zoom of wire in the hole.

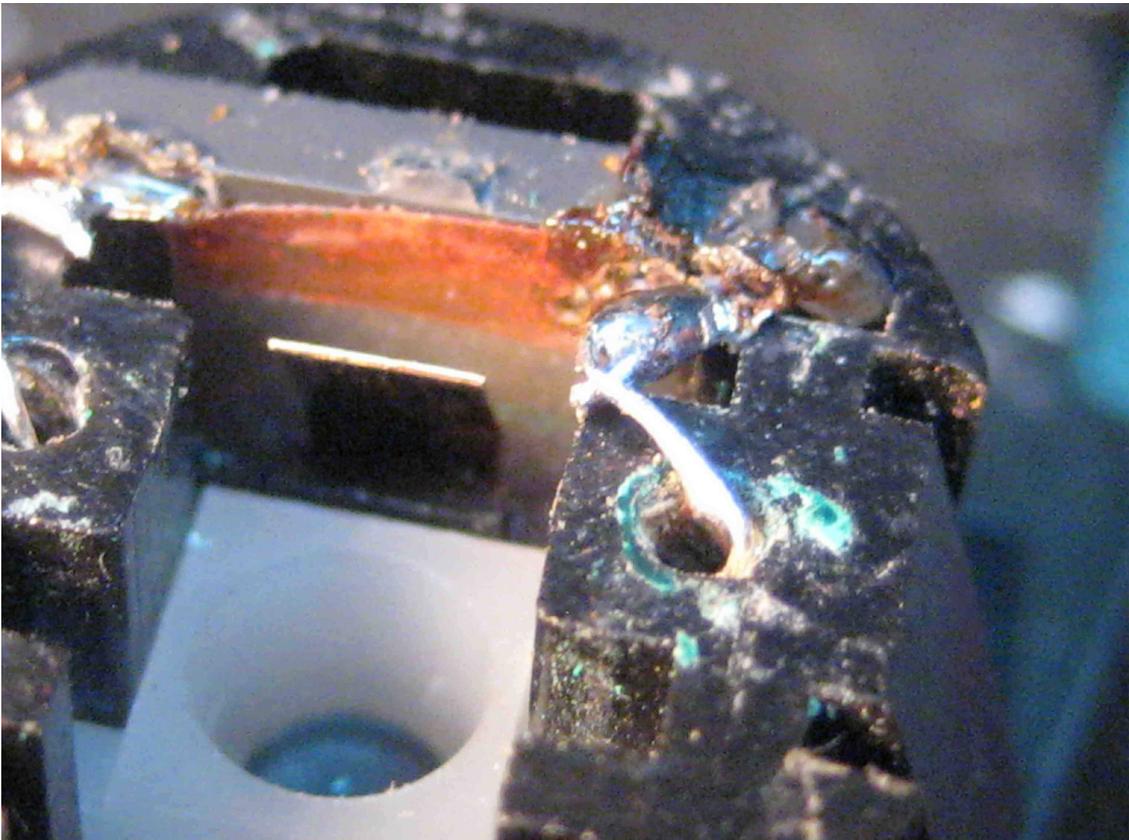
Other wire.
